Re: CarMax Auto Superstore West Coast, Construction Stormwater; SIC 1522; NPDES Compliance Evaluation Inspection; NPDES #NMU001957; January 3, 2018

NPDES Compliance Inspection Report

Banes General Contractors, Inc NMU001957 January 3, 2018

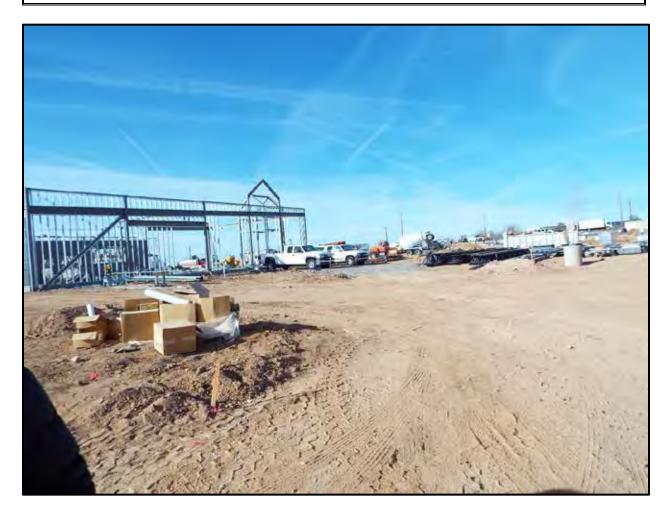
Photo # 1

Photographer: Daniel Valenta	Date: January 3, 2018	Time: 1003 hours					
City/County: Santa Fe/ Santa Fe County							
Location: 6820 Cerrillos Road, Santa Fe, New Mexico							
Subject: Construction site for the new CarMax Auto Superstore

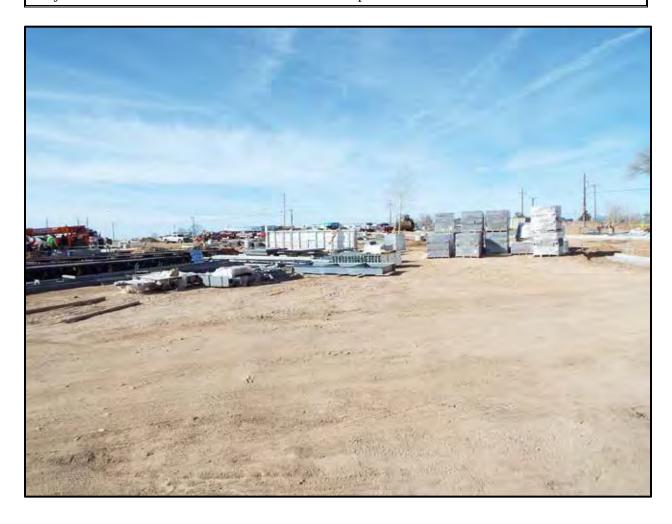
Photo # 2

Photographer: Daniel Valenta	Date: January 3, 2018	Time: 1045 hours					
City/County: Santa Fe/ Santa Fe County							
Location: 6820 Cerrillos Road, Santa Fe, New Mexico							
Subject: Construction site for the new CarMax Auto Superstore

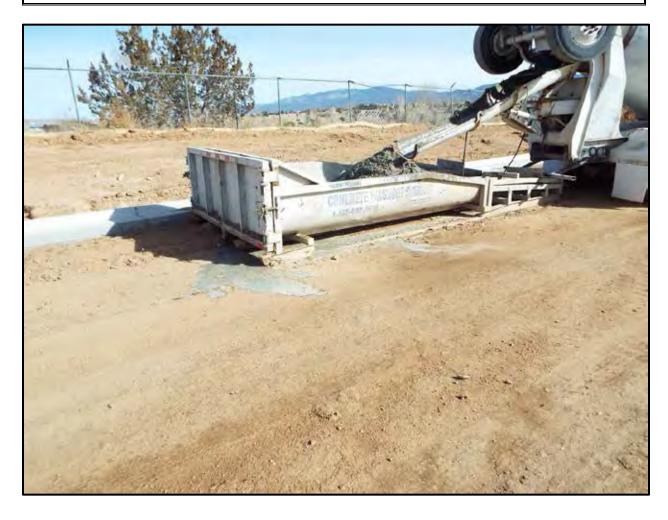
Photo #3

Photographer: Daniel Valenta	Date: January 3, 2018	Time: 1050 hours					
City/County: Santa Fe/ Santa Fe County							
Location: 6820 Cerrillos Road, Santa Fe, New Mexico							
Subject: Concrete washout leaking onto the ground.

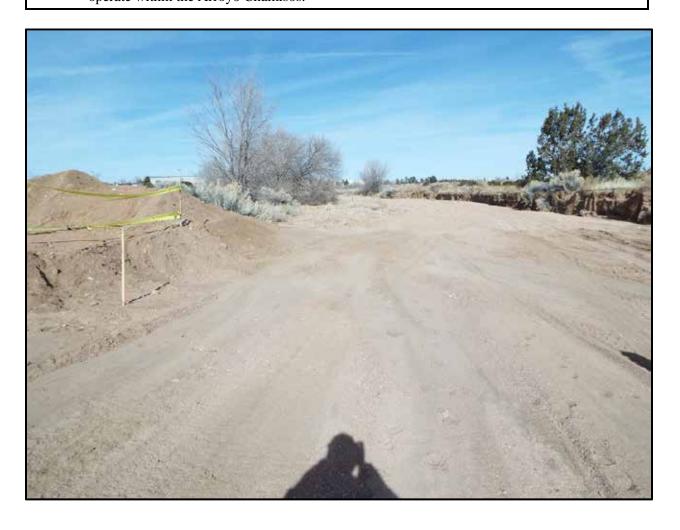
Photo #4

Subject: Soil disturbance up to the edge of the Arroyo Chamisos. The project had an 404 permit to operate within the Arroyo Chamisos.
